# **Evaluation of Freshwater Aquatic Resources and Stormwater Management at U.S. Naval Submarine Base, Bangor, Washington**

by Christopher W. May

Technical Memorandum  
**APL-UW TM6-97**  
December 1997

**Applied Physics Laboratory University of Washington**  
1013 NE 40th Street Seattle, Washington 98105-6698

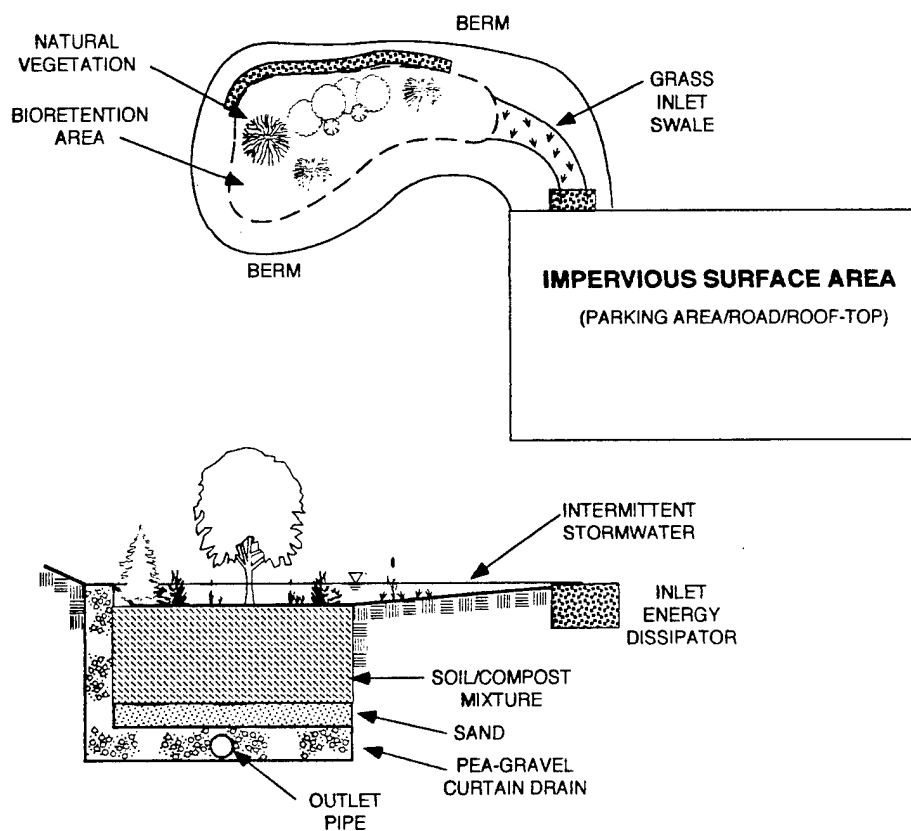
Bioretention systems are functionally similar to biotention and infiltration facilities but are designed to hold a volume of stormwater for an intermittent period of time. These facilities are appropriate only where standing water is not a problem. Figure 35 shows a bioretention area also used for treatment of impervious surface runoff. Figure 36 shows a typical bioretention filter such as would be used to service a parking lot.

**Figure 35.** Bioretention area.

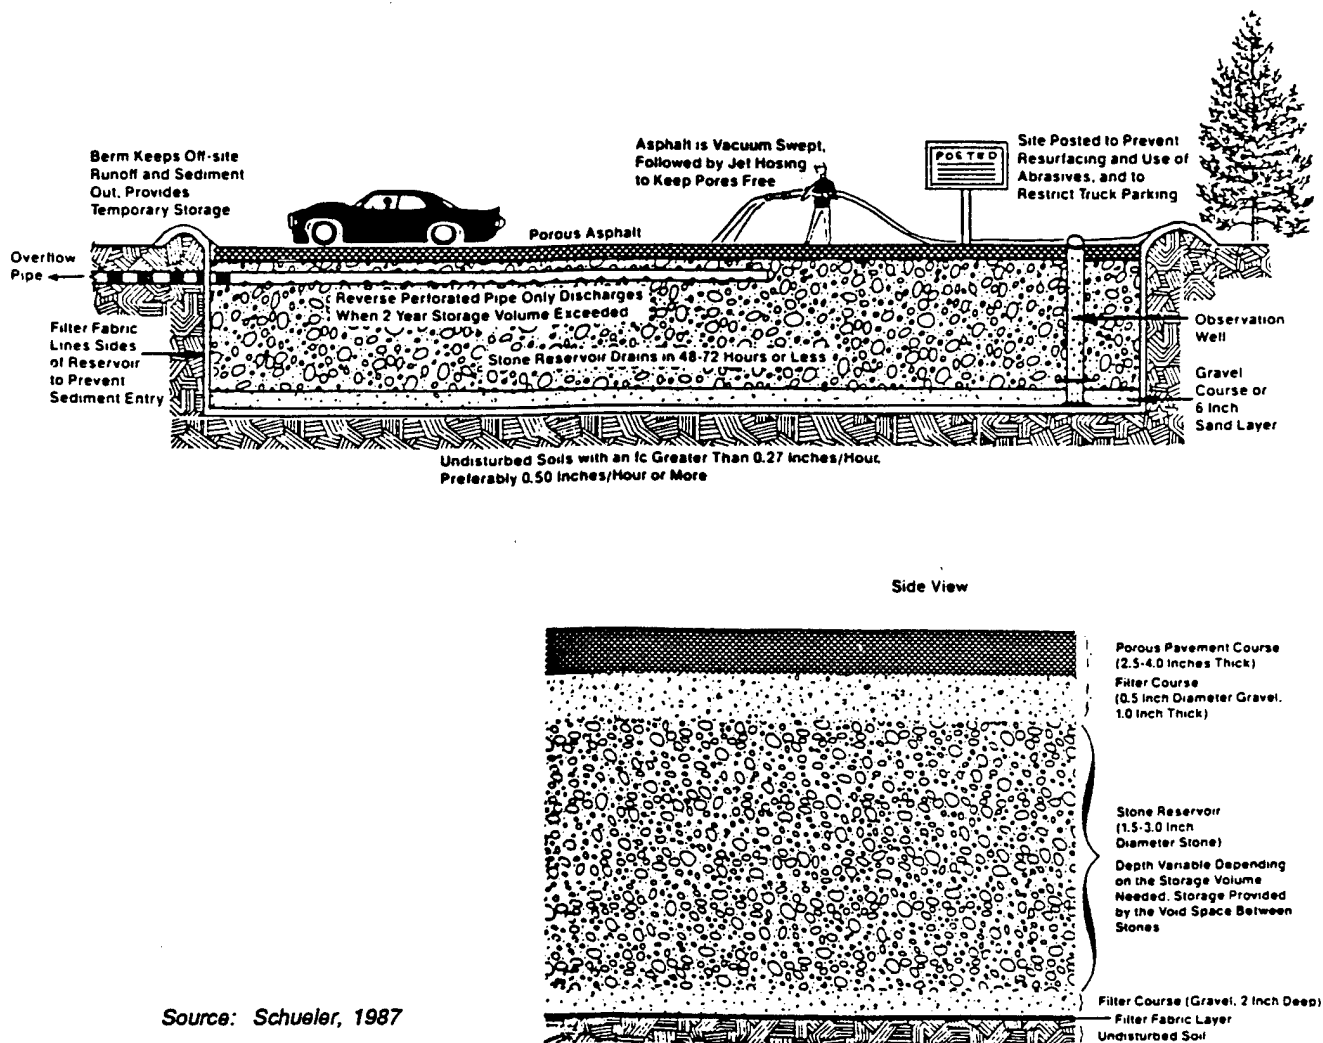
Figure 37. Porous pavement.

Porous pavement (PP) is an alternative to conventional pavement as a method of infiltrating stormwater and reducing impervious surface runoff. Typically, some type of porous asphalt or paver is utilized as the top surface over an excavated, underground gravel reservoir (Figure 37). Few performance or longevity data are available on these treatment systems, but PP systems have been shown to be effective in removing particulate and soluble pollutants. Many of the early porous pavement systems failed because of sediment clogging or for aesthetics reasons. The UW Center for Urban Water Resources is currently testing several variants of this system for use in parking areas or light-duty access roads. Construction costs for PP systems are higher than those for conventional pavement but can be offset by the savings in not having to build supporting treatment facilities.

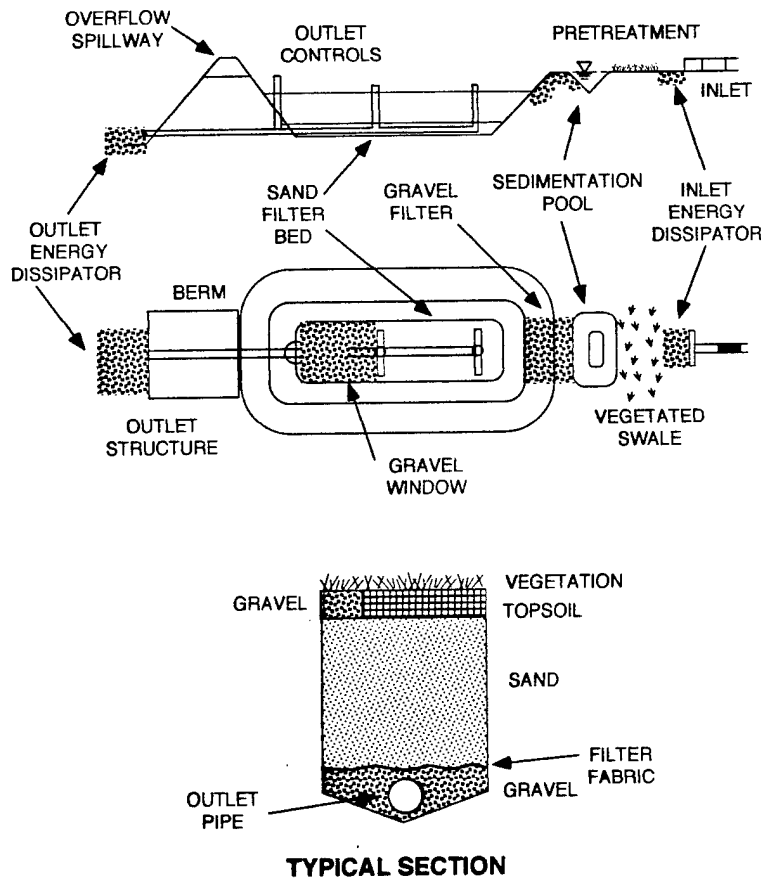
Figure 38. Sand filter system.

Sand filters are a relatively new and still fairly uncommon stormwater BMP facility. In these systems, stormwater is diverted into a basin with a bed of sand and an underground (perforated) piping network (Figure 38). Runoff is gravity filtered through the sand bed and collected in the pipes for distribution in the stormwater conveyance system. Enhanced sand filters may incorporate a layer of peat over the sand and/or a vegetated surface layer. Sand filters are highly effective at removing particulates (the median removal rate for TSS is 83%) but only moderately effective on soluble pollutants. The construction costs are a bit higher for sand filters than for conventional BMP facilities, and the maintenance costs are comparable. Sand filters do not appear to be prone to sediment clogging. These facilities are useful in watersheds where groundwater contamination is of concern. Small sand filters can also be employed to treat pollutant hot spots.

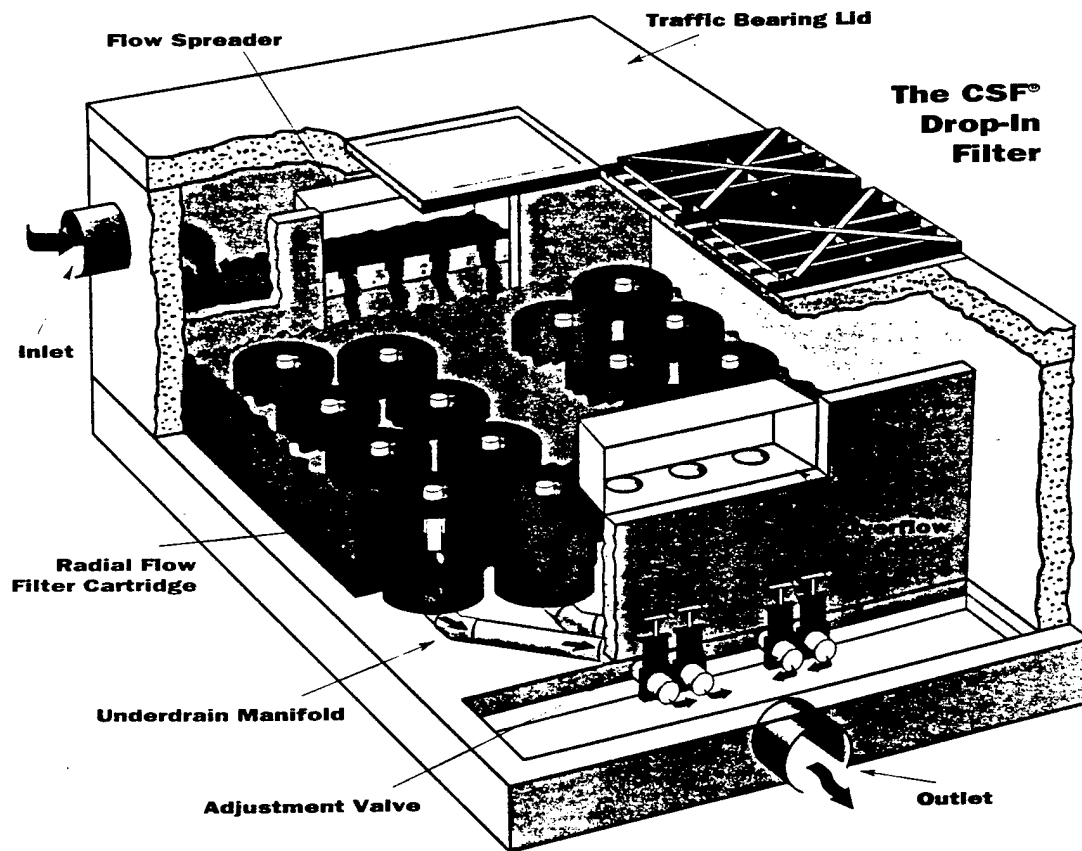
Figure 40. CSF® compost filter media (Stormwater Management, Inc.)

Compost media filters are also excellent on-site stormwater treatment systems. The CSF® system designed and built by Stormwater Management of Portland, Oregon, is the state-of-the-art product. It uses a pelletized, deciduous leaf compost to filter out petroleum products, metals, sediment, nutrients, and other pollutants. The compost is put into radial-flow cartridges which are inserted into precast concrete vaults or custom designed structures that are installed on site. Various drop-in and above-ground configurations have been built (Figure 40). Primary treatment is accomplished by a combination of adsorption, mechanical filtration, and ion exchange. The CSF design has been demonstrated to remove up to 90% of particulates, 85% of oils and greases, and 98% of metals. The CSF system typically utilizes about 10% of the space required for conventional stormwater treatment facilities, making it ideal when space is limited. The cost of the CSF design is also very competitive (approximately \$1000 per cartridge, which treats 15 gal/min of runoff).

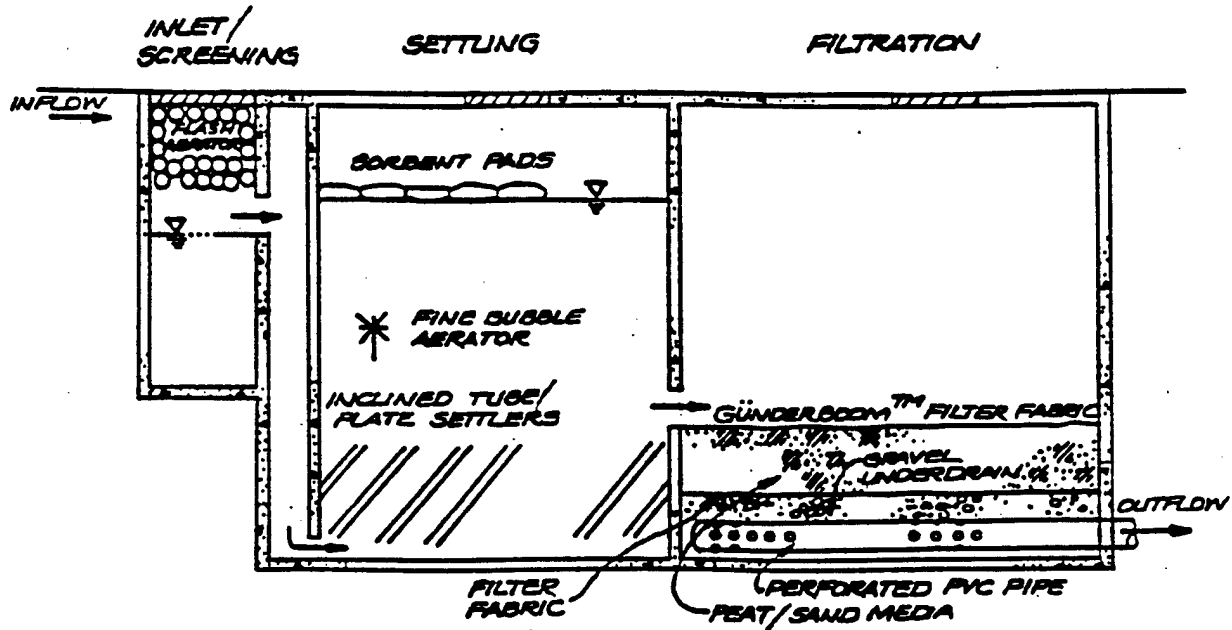
*The multi-chamber treatment train (MCTT) consists of three treatment units in sequence—an inlet screening chamber, a sedimentation chamber and a filtration chamber. Most of the high pollutant removal occurs in the last two chambers.*

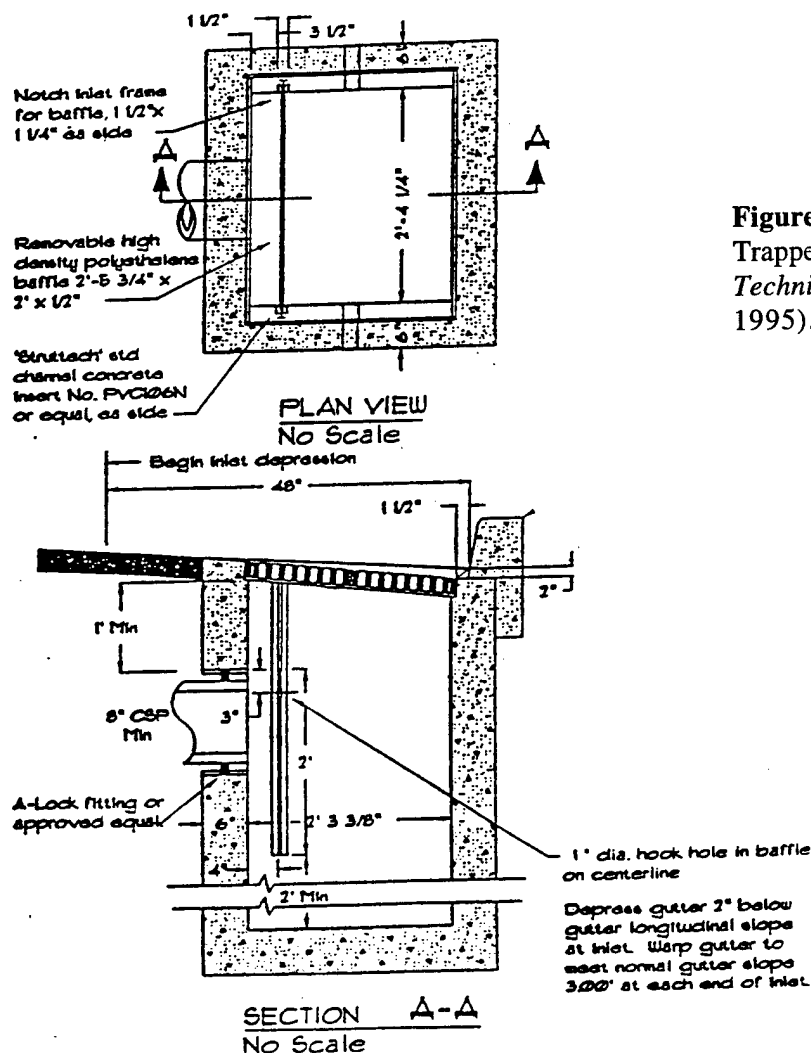
This is an excellent example of a preventative BMP facility. Inspection and removal of large debris from stormwater inlets should be performed on a regular basis (at least monthly and possibly weekly during the storm season). Stenciling of storm drains has also been demonstrated to raise public awareness. More thorough storm-drain cleaning should be done at least annually prior to the start of the winter rains. Vacuum extraction appears to be the most efficient method of cleaning, although manual methods also work. Installation of commercially available, "drop-in" retrofit filters or locally manufactured retrofit filters (Figure 43) in selected catch basins should be considered. Areas where heavy automobile traffic can be expected to produce higher levels of particulate pollutants, metals (zinc and lead), and petroleum hydrocarbons are good candidates for these filter inserts.

**Figure 43.**  
Trapped catch basin (*Portland Technical Guidance Handbook*, 1995).

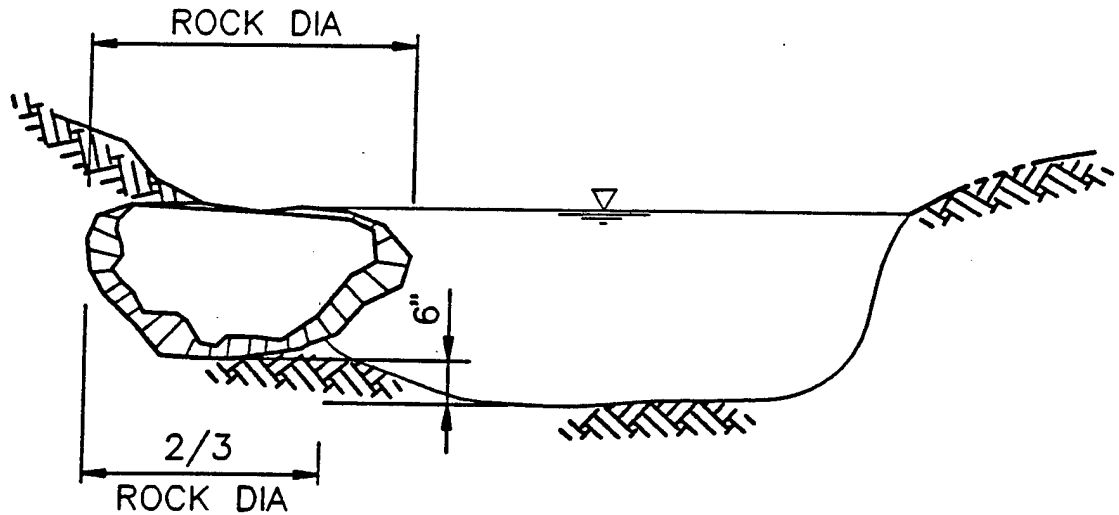
ONE-MAN ROCK  
BANK PROTECTION  
TO BE MINIMUM OF  
2' ABOVE TOP OF  
LOG. TRANSITION  
INTO EXISTING  
BANKS

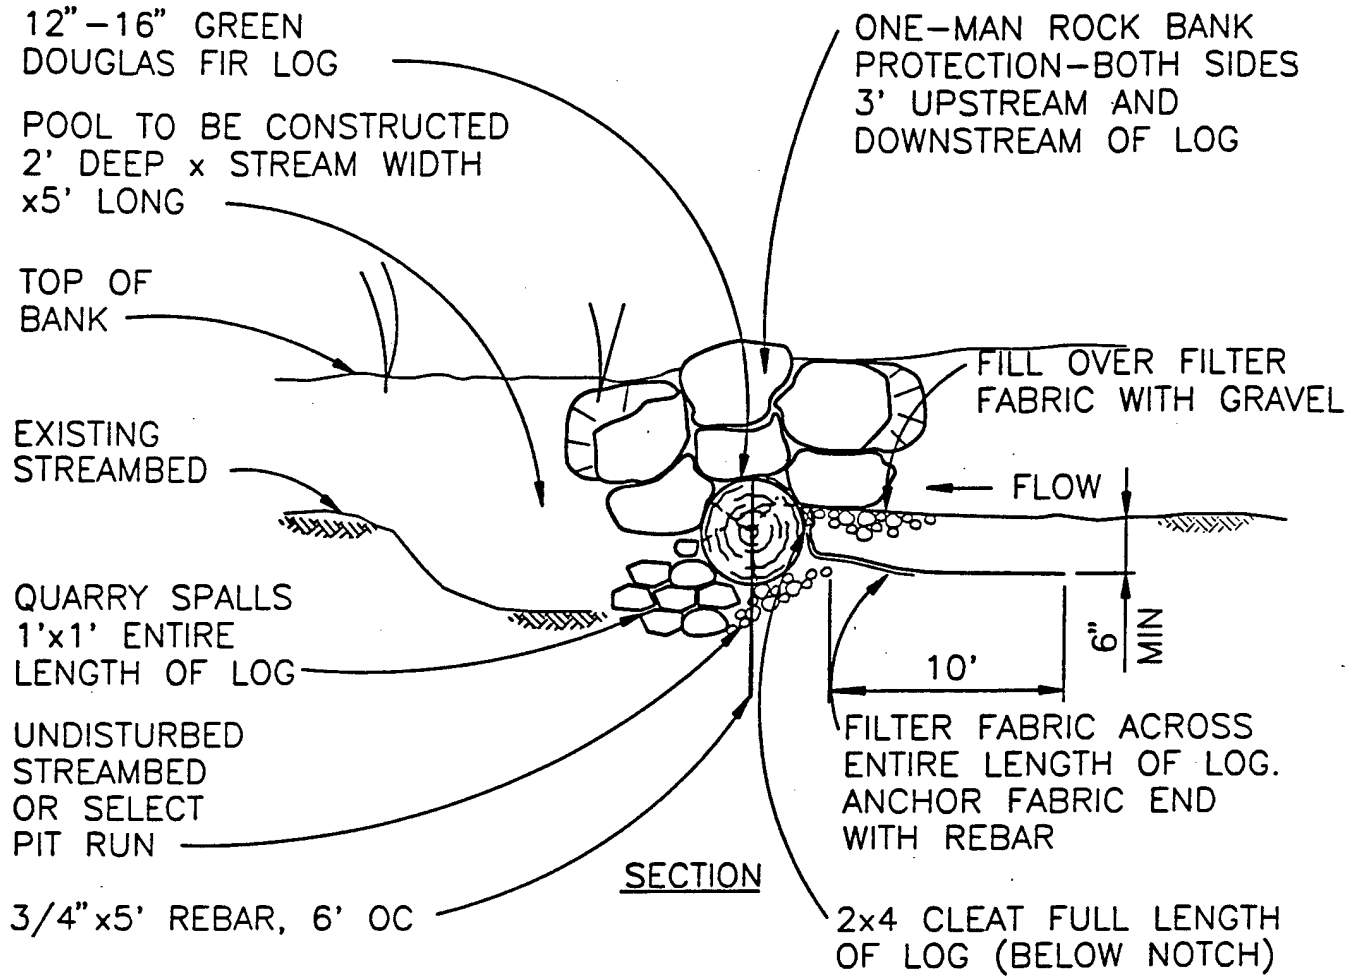
# LOG WEIR

NOTCH DEPTH = 4"  
NOTCH DETAIL
